COMMISSION ON AGING

320 W. Woodlawn Ave.
Hastings, MI 49058

10,180 Gross S.F.
(Excluding basement and outbuildings)

Originally unknown, Renovation 2002

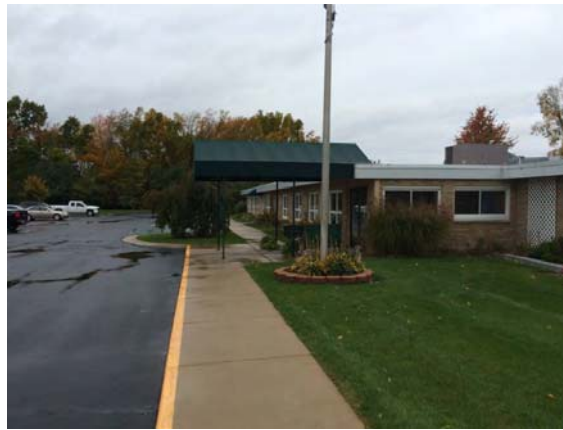
Poor. The 10,000 square foot facility was a former church which was converted to the current use and has had multiple additions over time. It is wood-frame construction with wood trussed shingled roof. The mechanical systems are residential-type furnaces distributed around the facility. The siting of the building causes water to shed toward the foundation and has resulted in water issues in the building. The wall construction is damaged from extended water exposure. Due to the multiple roofing systems, the roof currently has many issues water penetration and leaks.

Useful Life – The condition of the building is beyond its useful life without major reconstruction or remediation of issues. The wood framing is deteriorating from continued water exposure.

HVAC Efficiency – A building of this size should not have residential furnaces as its HVAC system.
